**Flood Control Project Maintenance
Levee Inspections****LMA District Cover Sheet****Spring 2015 Levee Inspection Results****Sutter Maintenance Yard Maintenance Area 0016**

Levee Inspection Report By Mile - Spring 2015

Sutter Maintenance Yard Maintenance Area 0016

Waterway	Bank	Unit Miles	Inspection Start/End	Inspector
Unit No. 01 Feather River	Right	4.06	05/05/2015 05/05/2015	Michael Pitta

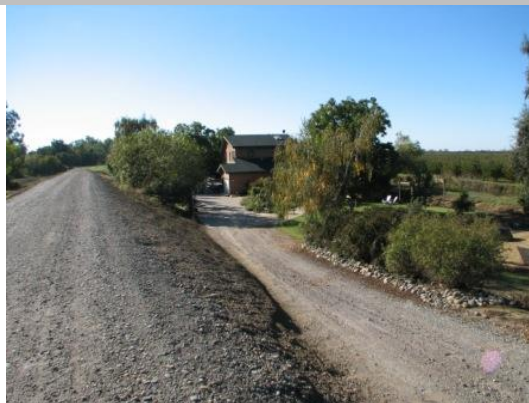
Photo 1 of 1 : SP_2015_MA0016_302_2_20150401_00001.jpg

LM Start	0.06	Rating **	M	Issue No.	2
LM End	0.10	Issue Type +	En	Location *	LS
Category	Earthen Levee			GPS Latitude/Longitude	
				Start	End
Item	Vegetation			39.256618 °	39.257228 °
				-121.636442 °	-121.636462 °
DWR ID	DWR_MA0016_01_s_2012_2				
Action/Comments					
Landscaping

Levee mile 0.10. This photo shows the landscaping on the landside slope and toe.

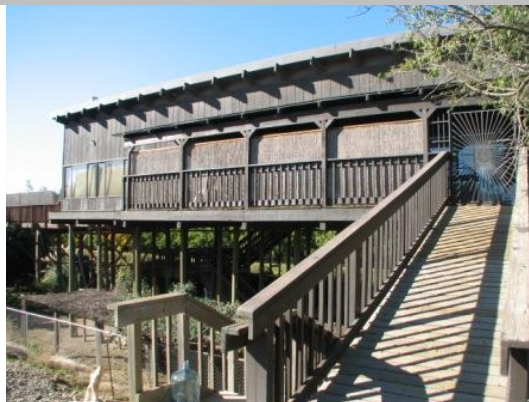
Photo 1 of 1 : SP_2015_MA0016_302_15_20150401_00008.jpg

LM Start	0.18	Rating **	M	Issue No.	15
LM End	0.18	Issue Type +	En	Location *	LS
Category	Earthen Levee			GPS Latitude/Longitude	
				Start	End
Item	Encroachments			39.258437 °	39.258437 °
				-121.636613 °	-121.636613 °
DWR ID	DWR MA0016 01 s 2012 15

Action/Comments					
Building

Levee mile 0.18. This photo shows the building on the landside shoulder and toe.

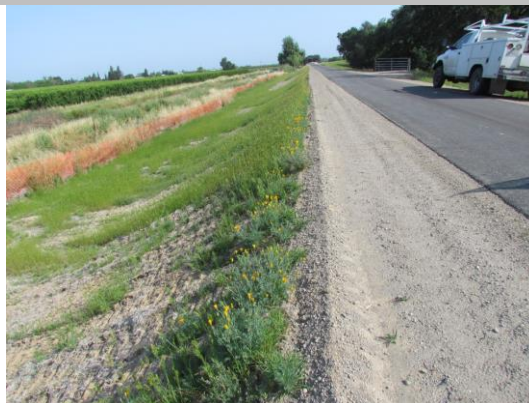
Photo 1 of 1 : SP_2015_MA0016_302_16_20150505_00009.jpg

This view of the vegetation was taken on the landside facing upstream

LM Start	0.26	Rating **	A/W	Issue No.	16
LM End	3.19	Issue Type +	Ma	Location *	LS
Category	Earthen Levee			GPS Latitude/Longitude	
				Start	End
Item	Vegetation			39.259598 °	39.298393 °
				-121.636628 °	-121.638324 °
DWR ID	DWR_MA0016_01_s_2015_16				
Action/Comments					
Control annual grass and weeds on the levee slopes and easements.

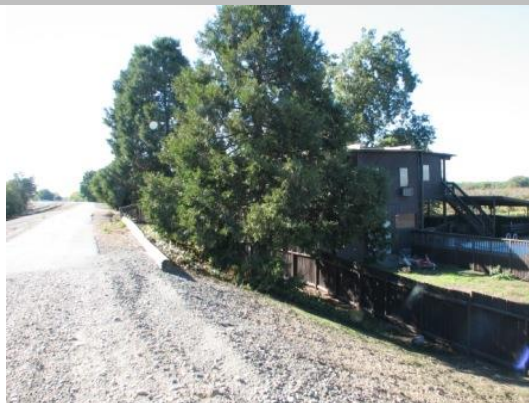
Photo 1 of 1 : SP_2015_MA0016_302_7_20150401_00002.jpg

LM Start	0.44	Rating **	U	Issue No.	7
LM End	0.49	Issue Type +	En	Location *	LS
Category	Earthen Levee			GPS Latitude/Longitude	
				Start	End
Item	Encroachments			39.262213 °	39.262825 °
				-121.636545 °	-121.636430 °
DWR ID	DWR_MA0016_01_s_2012_7				
Action/Comments					
Building

Levee mile 0.49. This photo shows the building and landscaping on the landside slope and toe.

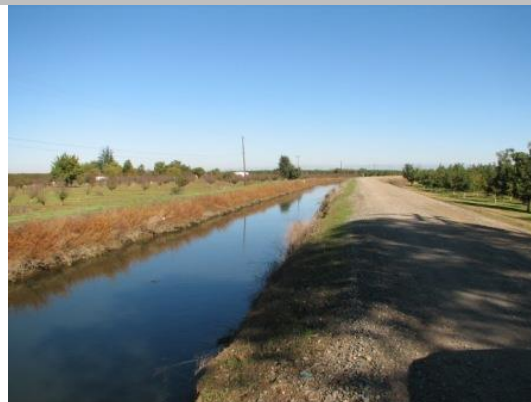
Photo 1 of 2 : SP_2015_MA0016_302_14_20150401_00006.jpg

LM Start	2.85	Rating **	M	Issue No.	14
LM End	3.08	Issue Type +	En	Location *	LS
Category	Earthen Levee			GPS Latitude/Longitude	
				Start	End
Item	Encroachments			39.293675 °	39.296748 °
				-121.636615 °	-121.638192 °
DWR ID	DWR_MA0016_01_s _ 2012_14				
Action/Comments					
Ditch

Agricultural ditch land side slope and toe.

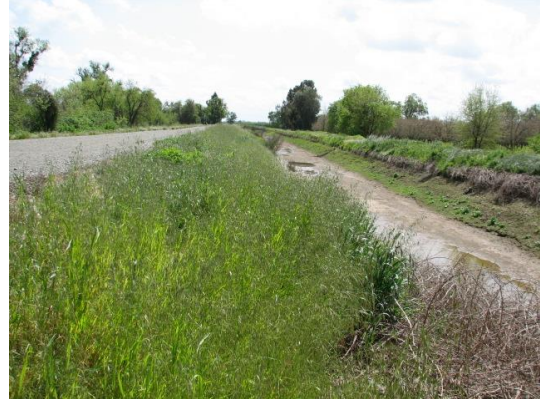
Photo 2 of 2 : SP_2015_MA0016_302_14_20150401_00007.jpg

LM Start	2.85	Rating **	M	Issue No.	14 (cont)	
LM End	3.08	Issue Type +	En	Location *	LS	
Category	Earthen Levee			GPS Latitude/Longitude		
				Start		End
Item	Encroachments			39.293675 °		39.296748 °
				-121.636615 °		-121.638192 °
DWR ID	DWR_MA0016_01_s_2012_14					
Action/Comments						
Ditch

Land side ditch levee mile 3.08.
